Skagit County 1923 Courthouse Windows

Window Material Condition, Surface Preparation, and Paint Requirements

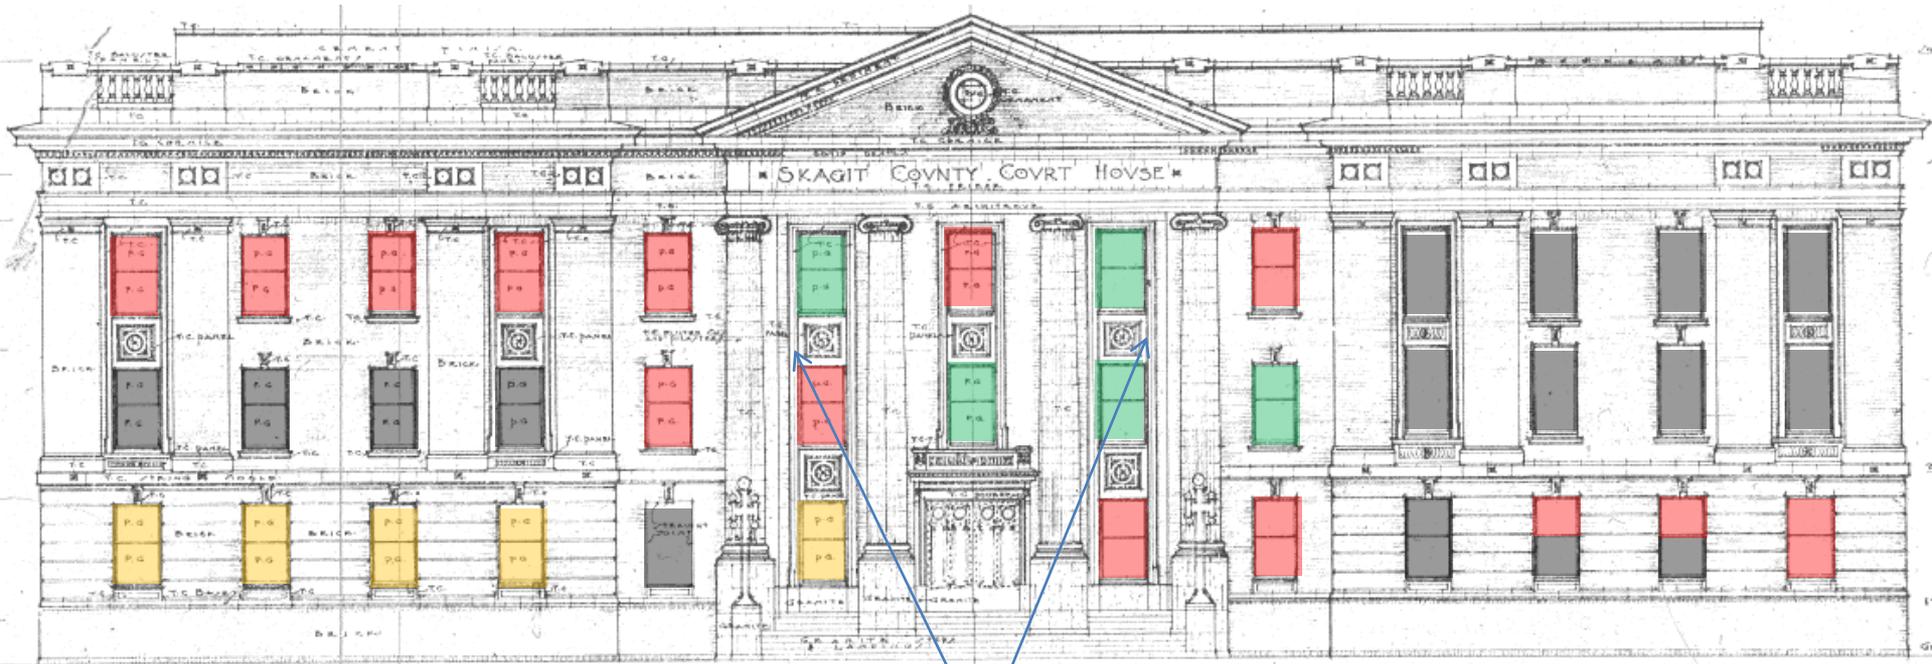
Courthouse Windows – South Face

Original Wood
Wood Replacement
Vinyl
Brick & Glass Block

Four more windows in the covered entry

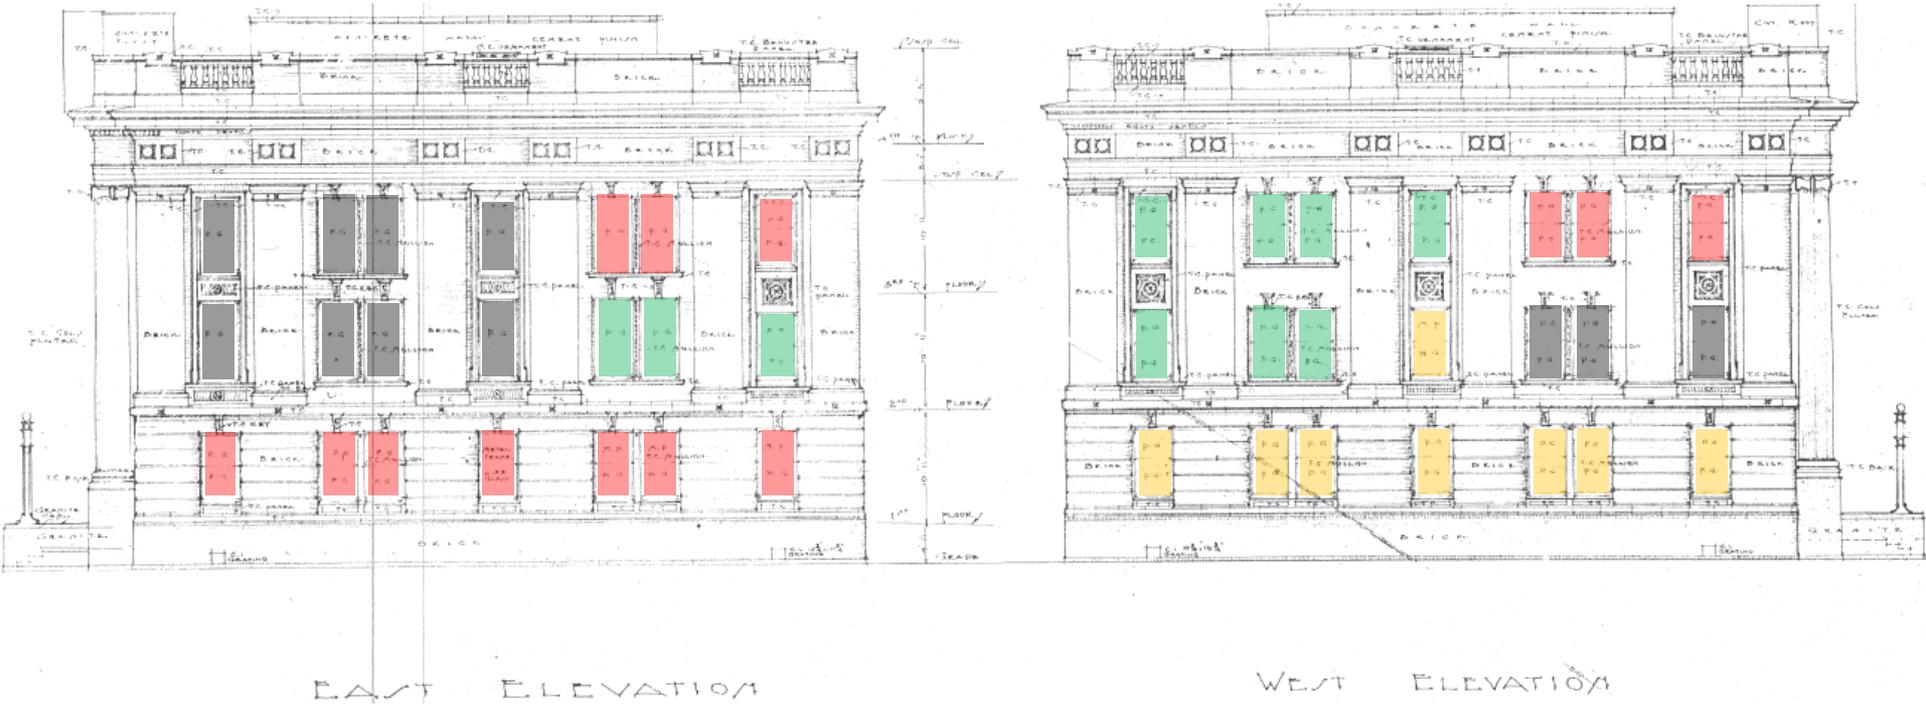
Courthouse Windows - Sides

Original Wood

Wood Replacement

Vinyl

Brick & Glass Block

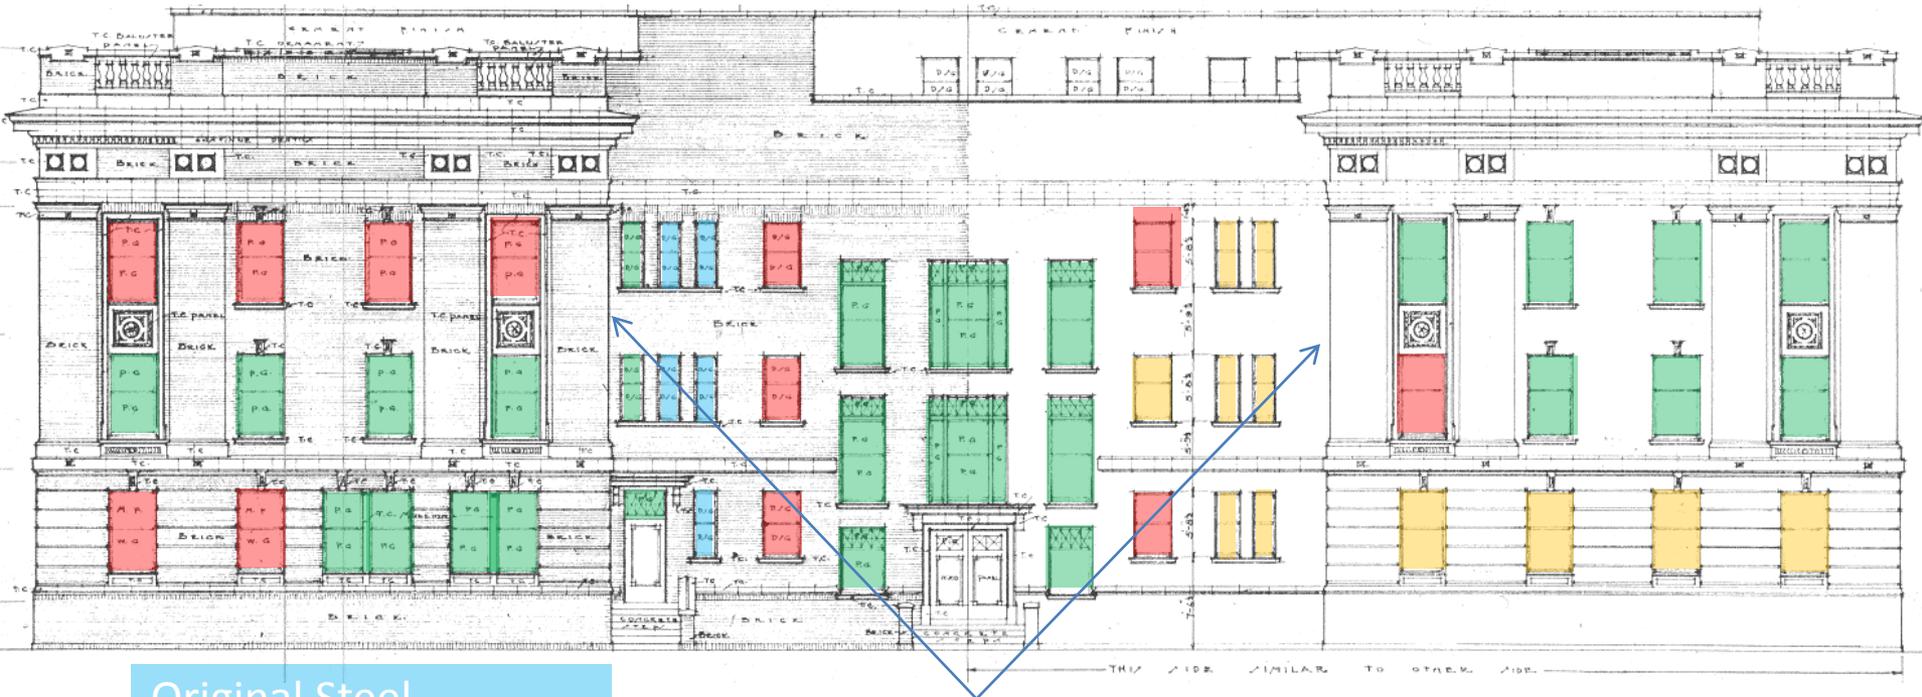
Courthouse Windows – North Face

Original Steel

Original Wood

Wood Replacement

Vinyl

Brick & Glass Block

Three more windows on offset east and west facing walls
