RECORD OF SURVEY
 IN A PORTION OF THE
 NE 1/4 OF THE NE 1/4 OF
 SECTION 7 AND THE NW 1/4
 OF THE NW 1/4 OF SECTION 8,
 T34N, R6E, W.M.,
 SKAGIT COUNTY, WASHINGTON
 SHEET 1 OF 3

RECORD OF SURVEY

IN A PORTION OF THE
NE 1/4 OF THE NE 1/4 OF
SECTION 7 AND THE NW 1/4
OF THE NW 1/4 OF SECTION 8,
T34N, R6E, W.M.,
SKAGIT COUNTY, WASHINGTON
SHEET 3 OF 3

NARRATIVE:
THE PURPOSE OF THIS SURVEY WAS TO MONUMENT THE NE QUARTER OF SECTION 7, THE NW QUARTER OF THE NW QUARTER OF SECTION 8, MARK THE NORTH LINE OF THE NW QUARTER OF SECTION 7, THE WEST AND SOUTH LINES OF THE NE QUARTER OF SECTION 7 AND THE SOUTH LINE OF THE NW QUARTER OF SECTION 8. I USED LEICA 1200 GPS RECEIVERS FOR A STATIC CONTROL NETWORK USING CORPS DATA CONstrained TO POINTS "75E1", "5E1", "WH06" AND "R176". I SET POINTS NEAR THE EAST, WEST AND NORTH QUARTER CORNERS OF SECTION 7 AND NEAR THE NW 1/16 CORNER OF SECTION 8. I DIRECT TIED THE NE, SE AND SW CORNERS OF SECTION 7 WITH IRK. I THEN USED A LEICA TOR 1203 TOTAL STATION TO RUN A RANDOM CLOSED TRAVERSE LOOP FROM SAID STATIC CONTROL NEAR THE NORTH QUARTER CORNER OF SECTION 7, EAST ALONG THE NORTH LINE OF SECTION 7 TO THE EAST 1/16th CORNER OF SECTION 7, SOUTH TO THE NE 1/16th

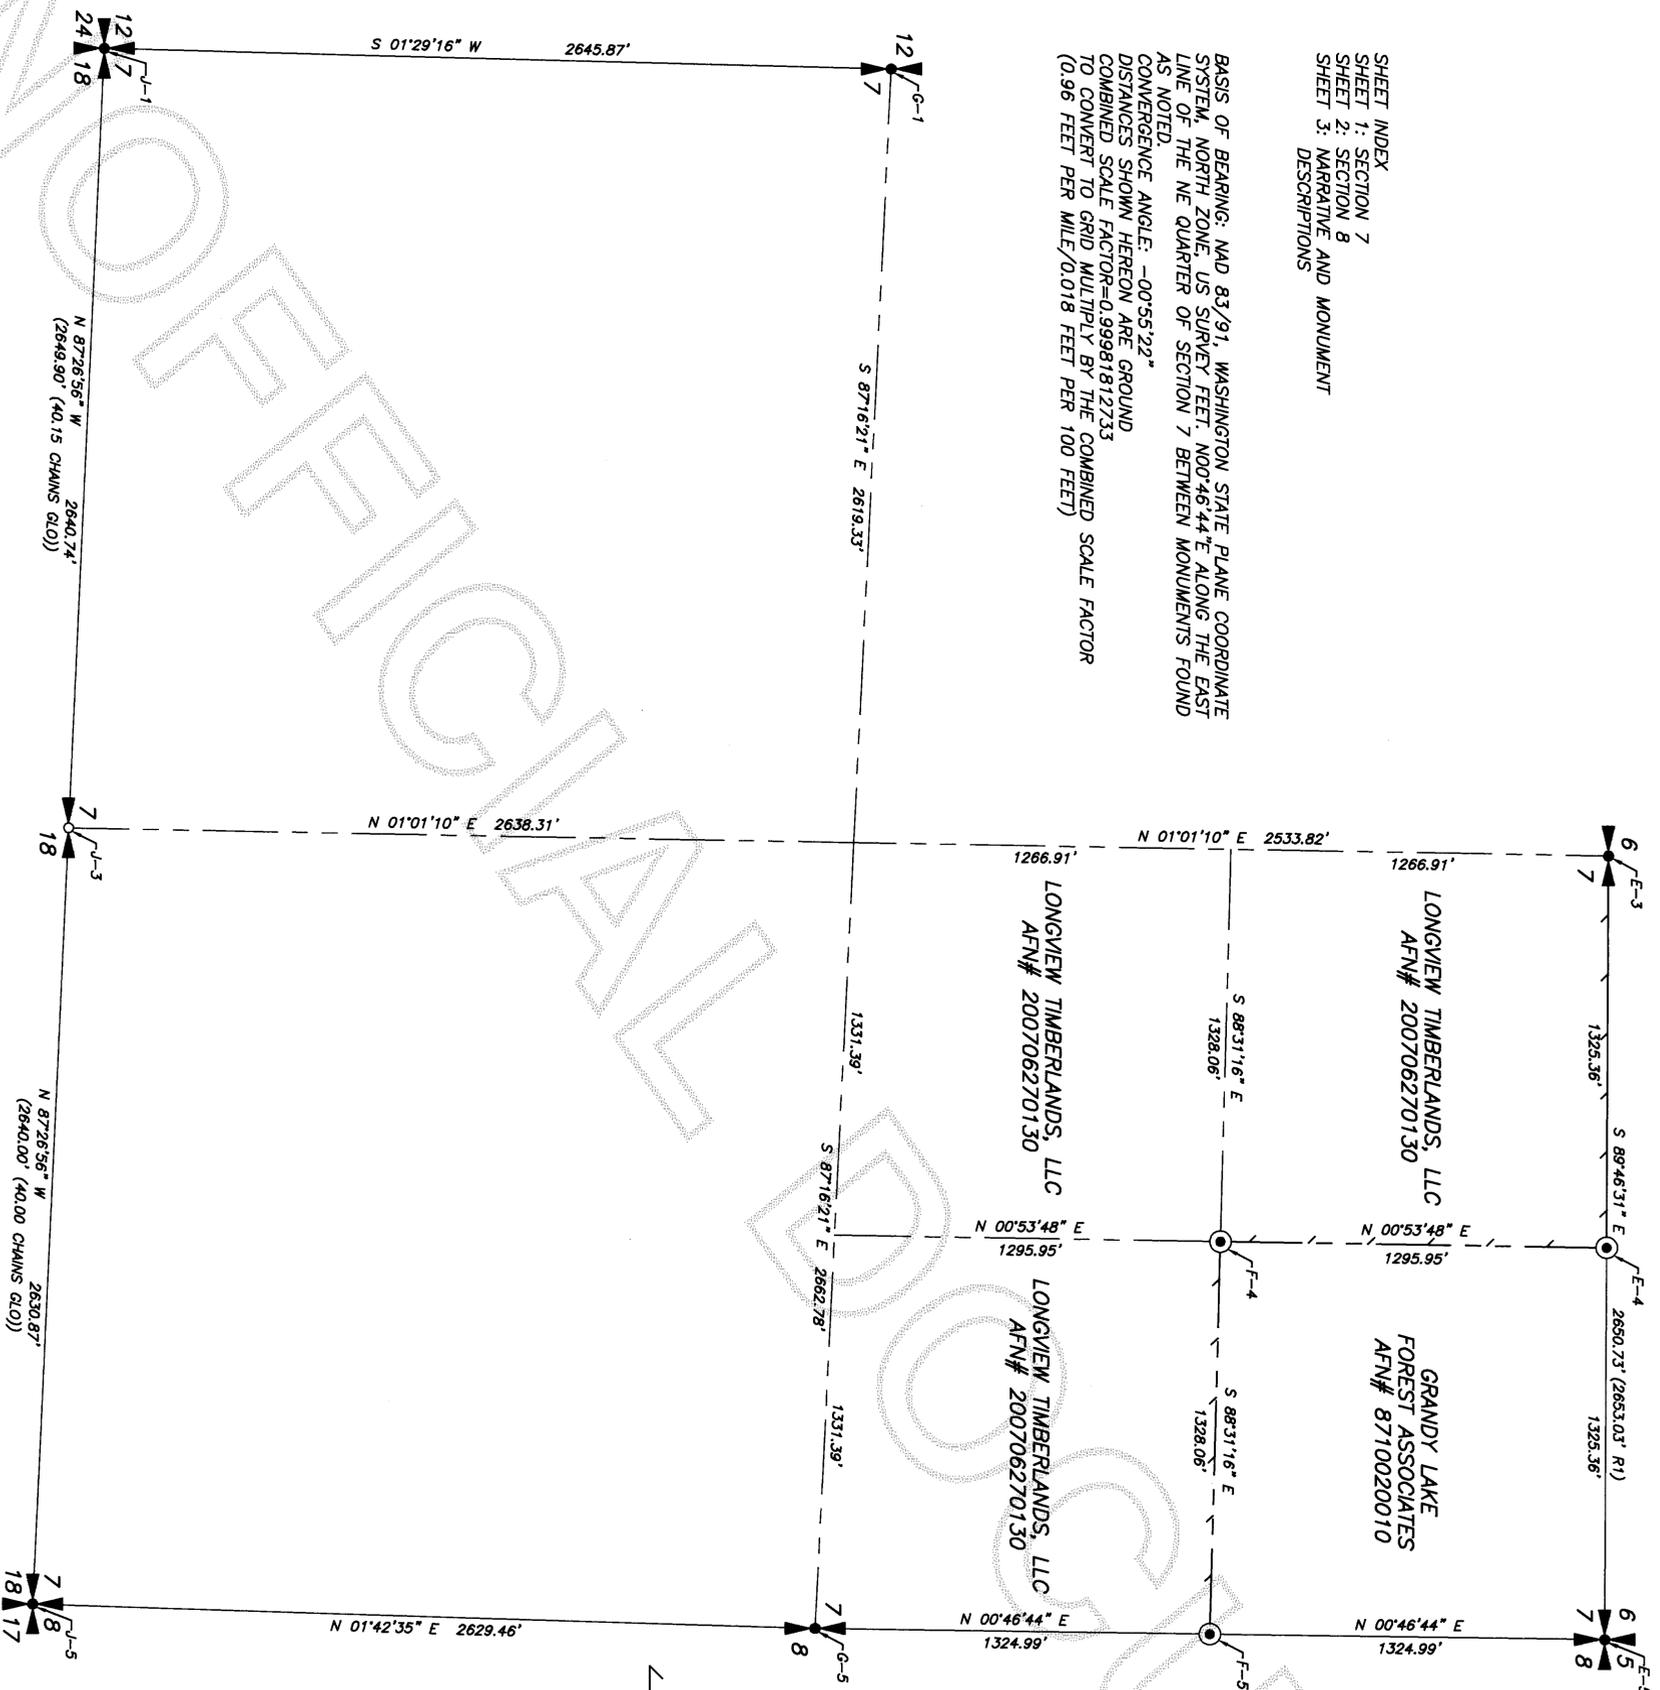
BASIS OF BEARING: NAD 83/91, WASHINGTON STATE PLANE COORDINATE SYSTEM, NORTH ZONE, US SURVEY FEET, N00°46'44" E ALONG THE EAST LINE OF THE NE QUARTER OF SECTION 7 BETWEEN MONUMENTS FOUND AS NOTED.
 CONVERGENCE ANGLE: -00°55'22"
 DISTANCES SHOWN HEREON ARE GROUND
 COMBINED SCALE FACTOR=0.99981812733
 TO CONVERT TO GRID MULTIPLY BY THE COMBINED SCALE FACTOR (0.96 FEET PER MILE/0.018 FEET PER 100 FEET)
