AUDITOR'S CERTIFICATE

- 5. The Field Survey was conducted March, 2015, Corners set March 17, 2015,
- 6, Set and or verified the property comers of George M. and Patricia L. Hatfield property at 1408–15th Street, Parcel No., 55755,

Geomatic Consultant

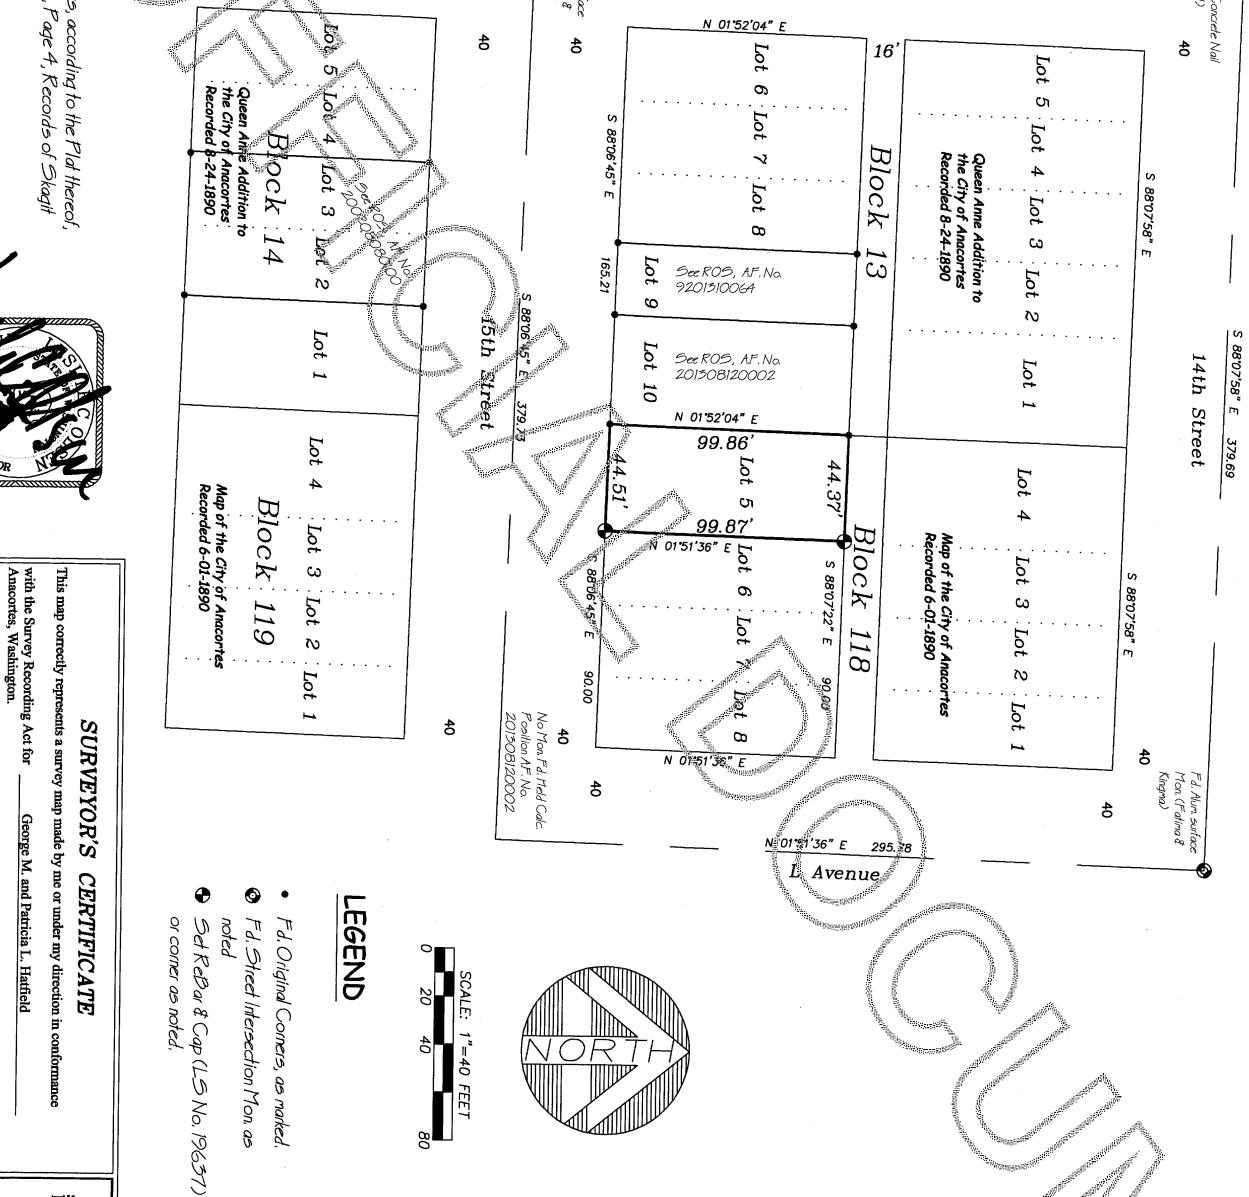
N 01°52'04" E 295.65

- 7. Found property corners of three (3) ROS's as noted; Auditor's File Nos, 201508120002, 9201510064 and 200208080100,
- 8. Survey held street monumentation and Record of Surveys corners as found.

- 9. This survey was performed to locate the boundaries of Lot 5, Block 118, Plat of
- 10. This survey locates all or portions of the exterior boundary of the described parcel and does not necessarily show any or all easements, restrictions and or reservations which may affect this parcel. FairWeather Survey assumes no responsibility for any encumbrances other than those shown.
