LAND MOVEMENT

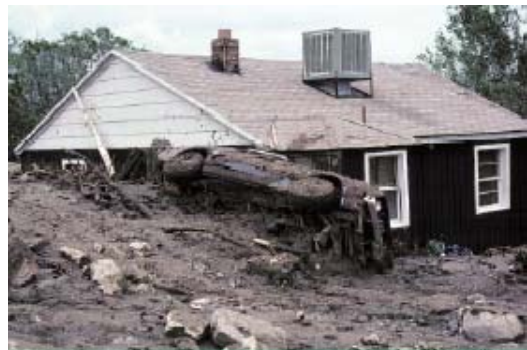
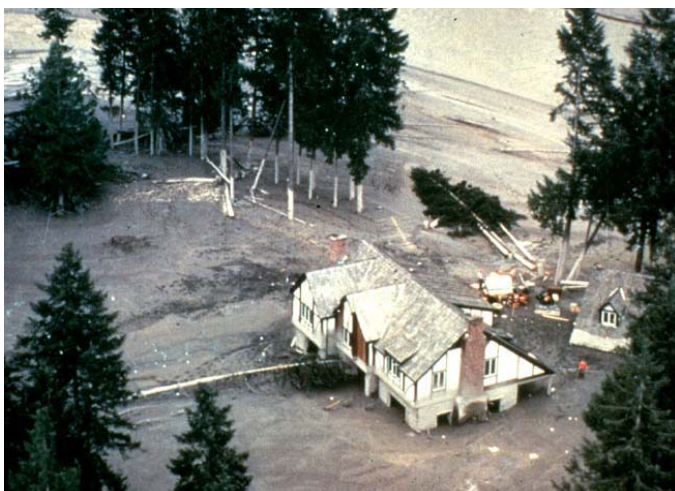
Among the most destructive types of debris flows are those that accompany volcanic eruptions. The picture at left is of a house located along the North Fork of the Toutle River that was damaged from an extremely large debris flow (called a lahar) resulting from the 1980 eruption of Mount Saint Helens. This debris flow traveled about 14 miles down the valley destroying roads, bridges, and approximately 200 homes. The depth of the debris flow can be noted by the light gray coloration on the trees.
